COMMON INSTALLATION FAILURE MODES FOR IN-SERVICE PLASTIC PIPING COMPONENTS AND SYSTEMS

Dr. Bryan E. Hauger, Microbac Laboratories, Inc. – Hauser Laboratories Division, Boulder, CO
Steve Ferry, Microbac Laboratories, Inc. – Hauser Laboratories Division, Boulder, CO
Russ Willacker, Microbac Laboratories, Inc. – Hauser Laboratories Division, Boulder, CO

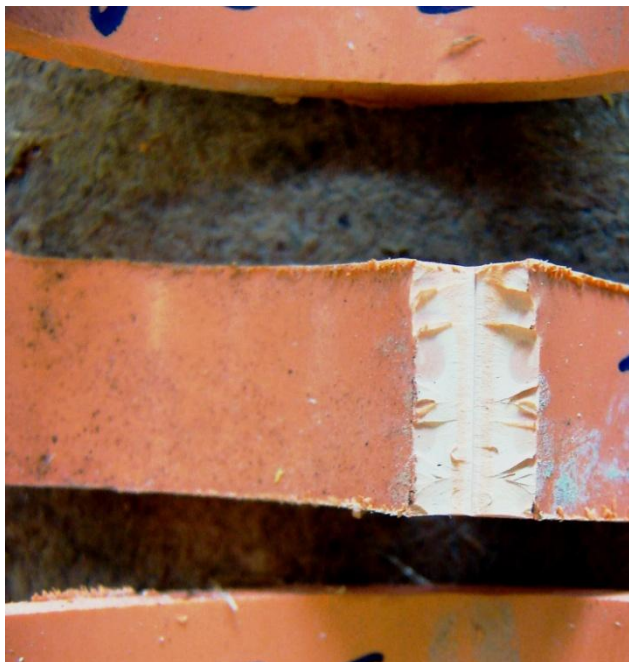
Numerous samples of CPVC piping and fittings were received from the client exhibiting signs of brittle fracture. A typical appearance of a CPVC pipe that has suffered exposure to ESC agents and subsequently failed in service is shown in Figure 1. The sample shows signs of localized crazing upon initial visual examination.

Figure 1: Digital image displaying a section cut from CPVC pipe with obvious brittle fracture zone. For scale, the pipe wall thickness is approximately 0.075 inches.

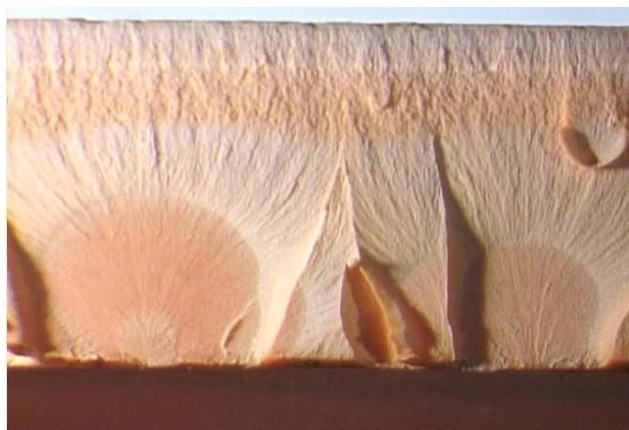
The same specimen from Figure 1 was then examined under low magnification light microscopy as shown in Figure 2. Under these conditions, multiple independent inner wall initiating “thumbnail” features are evident confirming identification of the failure as ESC.

Figure 2: Digital close-up image of the full thickness of the fractured CPVC pipe surface displayed above. Note that each “thumbnail” in the fracture represents a single fracture initiation, indicating that multiple initiations are present.

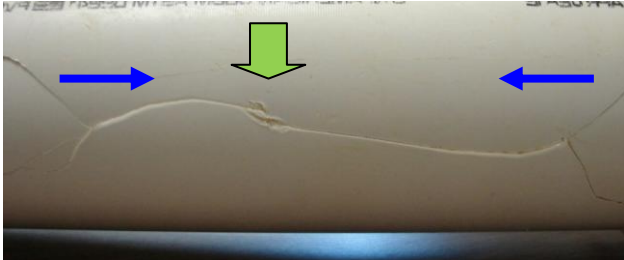
During sample recovery, it was established that a rock was in direct contact with the top of a 6” nominal ASTM D2241 SDR21 PVC pipe¹², with a larger rock on top of the impinging rock at the location of the fracture initiation (see Figure 3). The linear dimensions of large rock were obtained and the volume exceeded 1000 cubic inches. The mass of the rock was estimated to exceed 100 pounds. The printline of the pipe identified that at the time of removal from service, the pipe had been installed for less than 7 years.

Based on macrofractography, the overall fracture network in the sample is macroscopically brittle, although there is some amount of ductility visible on the outer surface near the initiation area. The fracture initiated near the outer wall of the pipe at a location coincident with the area of rock impingement (see Figure 3).

Figure 3: Digital image displaying the general fracture initiation area based on macrofractography, with previously-established rock-impingement location identified by the green arrow. The blue arrows denote “TOP” location (12 o’clock) in trench.

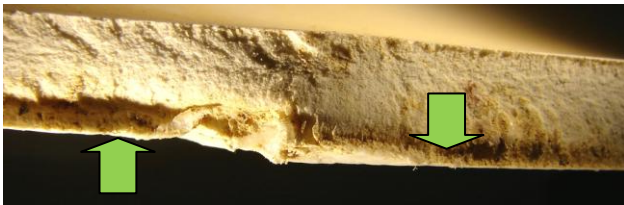
Figure 4: Digital image displaying the exterior rock impingement and fracture initiation area sectioned for SEM inspection. The rock-impingement location is generally bounded by the green arrows along the outside edge of the pipe which is down as shown in this photo. Note approximately 10-25% (thickness) penetration of the rock into the PVC pipe wall in wedge-like fashion.

Within this fracture initiation area, the fracture propagates radially through the pipe wall due to the impinging rock acting as a “wedge”, followed by axial propagation. The fracture then branches on each side of the impingement area and propagates generally axially via fast fracture, due to the stress field resulting from internal pressurization. The total fracture length was greater than 18 inches. There was no evidence of manufacturing defects such as voids, inclusions, or contamination present in the fracture surface. The fracture was a result of time-dependent overload caused by rock impingement

It is important to note that numerous installation standards provide prescriptive language regarding the impingement of rocks upon thermoplastic pipes. For example, ASTM D2774 (originally approved¹⁵ in 1969) states “The particle size of material in contact with the pipe shall not exceed the following: ½ in. for pipe to 4 in., ¾ in. for pipes 6 to 8 in.; 1 in. for pipes 10 to 16 in.; and 1½ in. for larger pipes.”

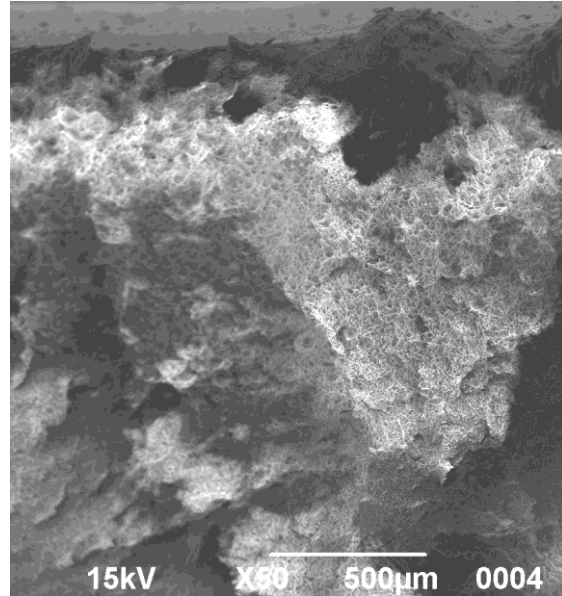
The fracture morphology in the initiation area is microscopically ductile, and is typical of time-dependent (slow) crack growth in PVC piping materials. As shown in Figure 5, the initiation site and area near the impingement at the outer pipe wall show significant ductility when viewed by low magnification SEM imagery. These ductile features at the outer wall give way to microscopically brittle features in the mid-wall as shown in Figure 6.

Figure 5: Low Magnification SEM digital image displaying the fracture surface near the outer wall initiation. Note microscopically ductile morphology.

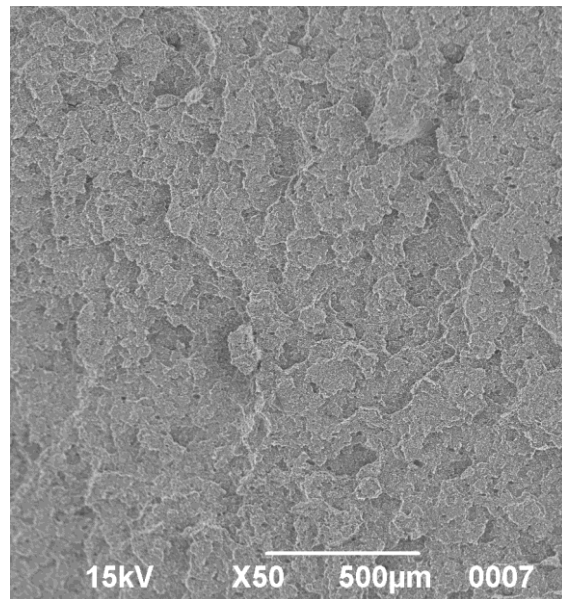
Figure 6: Low Magnification SEM digital image displaying the fracture surface in the mid-wall. Note microscopically brittle morphology.

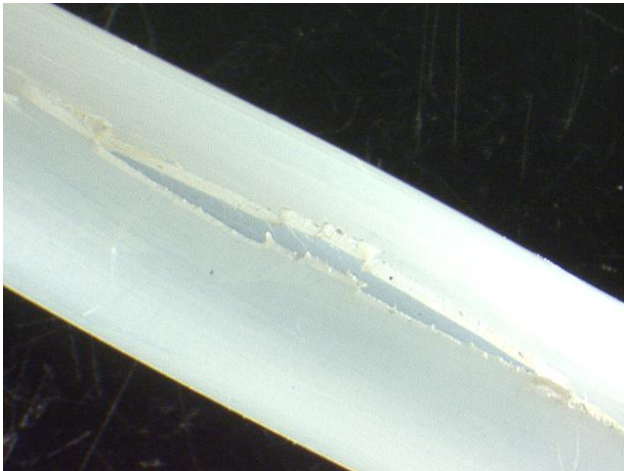
The Failed Sample was received from the client as unpigmented small diameter PE tubing greater than 4 feet in length with an interior “stain” adjacent to the through-wall fracture. The Failed Sample contained an axially oriented through-wall fracture approximately 1 inch in length (as shown in Figure 7) co-located with a significantly reduced radius of curvature. No manufacturing defects were present within the fracture surface. During visual inspection and optical microscopy, a second incipient fracture was observed near to the through-wall fracture. Additionally, an Exemplar Sample of similar unpigmented polyethylene (PE) tubing greater than 30 inches in length was received from the client.

Figure 7: Digital image of the Failed Sample showing the through-wall stepped fracture indicating multiple fracture initiations.

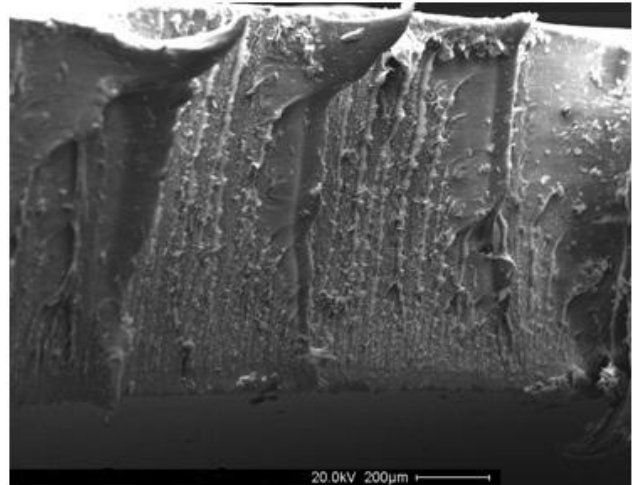
The through-wall fracture in the Failure Sample is macroscopically brittle and co-located within an area that displays reduced radius of curvature with multiple adjacent fracture initiations along the inner wall of the tube that join to form the through-wall fracture. There are no manufacturing defects present within the approximately 1 inch long fracture surface. The overall fracture network is typical of an environmental stress cracking failure mode, with multiple inner wall fracture initiations and through-wall propagation via slow crack growth (See Figure 8).

Figure 8: Digital SEM image of the fracture surface for the Failure Sample. Note stepped fracture indicating multiple fracture initiations, and progression from inner (at bottom of image) to outer wall (at top).

In summary, the Failure Sample failed by inner-wall initiating environmental stress cracking (ESC) failure mode co-located with reduced radii of curvature and hence mechanical stresses. A stain on the tubing interior was analyzed by various methods to attempt to identify a chemical responsible for ESC failure mode. Although the results were not sufficient to implicate a single chemical species, the FTIR test results clearly indicate that a residue illustrates the presence of chemical contamination. Results of 80°C hydrostatic pressure testing indicate that the Failed Sample has reduced residual service life expectations when compared to the Exemplar Sample. The reduction of service life and the multiple fracture initiation failure mode within the Failure Sample suggests that the Failed Sample has been compromised by the combination of the elevated stresses created by the reduced radius of curvature in combination with an environmental stress cracking agent.

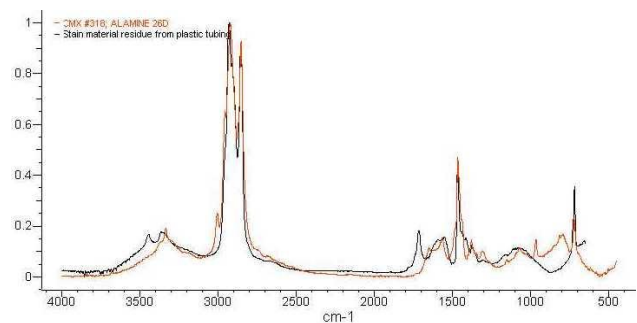
pressed material was analyzed by Fourier Transform Infrared (FTIR) spectrometry using a Thermo Nicolet 560 FTIR with a Thermo Nicolet Continuum microscope attachment, according¹⁶ to ASTM E334. The base material of the tubing was identified using the ATR-FTIR (Attenuated Total Reflectance) technique. Only poor quality matches for the stain material were generated by comparison to Biorad and/or locally-generated infrared spectral libraries with possible and/or partial matches including various amines, amides, alcohols, and glycol esters. Although a conclusive match was not obtained, the stained area clearly included other compositions aside from PE (see Figure 9).

Figure 9: FT-IR spectrum resulting from the stain material (in black) combined with an overlay of a reference material “Alamine 26D” (in orange). Note the similarity of the spectral features at the higher wavenumbers.
